INDEX (CHAPTER - G)

P0003 - SHORT CIRCUIT TO GROUND OF METERING UNIT OUTPUT

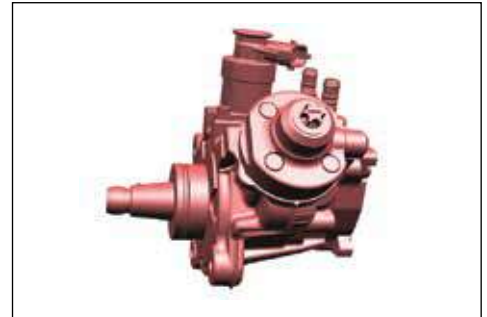
The metering unit is used for compressing the fuel at high pressure and sending it at pressurized stage towards the rail, which is controlled by ECU.

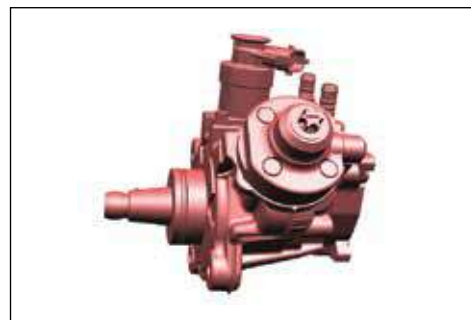
The metering unit is used for compressing the fuel at high pressure and sending it at pressurized stage towards the rail, which is controlled by ECU.

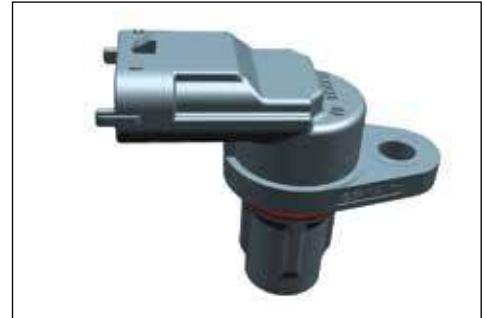
The Camshaft position sensor senses the Top dead center (TDC) point of the first cylinder in the compression stroke. This allows the ECU to determine when to start the injection.

Sensor records the rate at which the camshaft is spinning and this information is used by the ECU to control ignition and fuel injection.

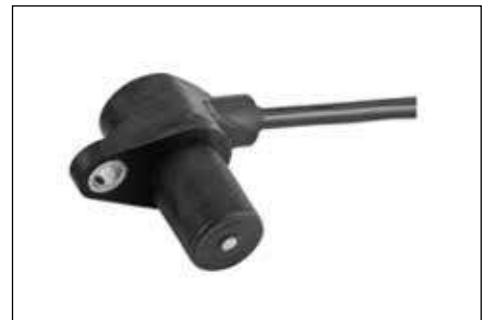
Crankshaft Speed Sensor

The crankshaft speed sensor (also known as the crank position sensor) is an electronic device used in an engine to record the rate at which the crankshaft is spinning. This information is used by the ECU to control ignition and fuel injection.

The sensor system consists of a rotating part, typically a disc, as well as a static part, the actual sensor. When the engine is running, the high and low parts of the teeth cause a change in gap with the sensor. The changing gap causes a change in the magnetic field near the sensor. The change in the magnetic field causes a change in the voltage from the sensor.

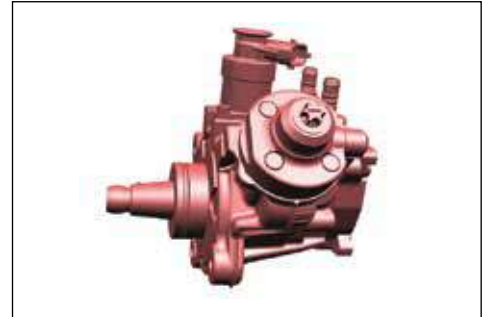
The metering unit is used for compressing the fuel at high pressure and sending it at pressurized stage towards the rail, which is controlled by ECU.

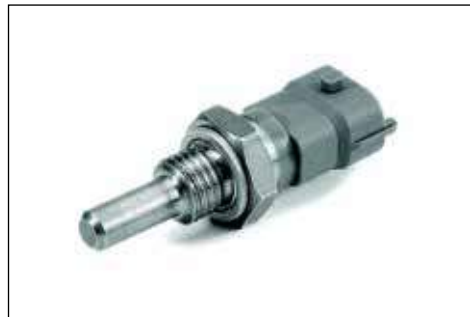
The sensor modifies a voltage signal from the electronic control unit (ECU).

The modified signal returns to the ECU as the engine coolant temperature input. The ECU checks CTS voltage and uses the information to help smoothen the engine operation.

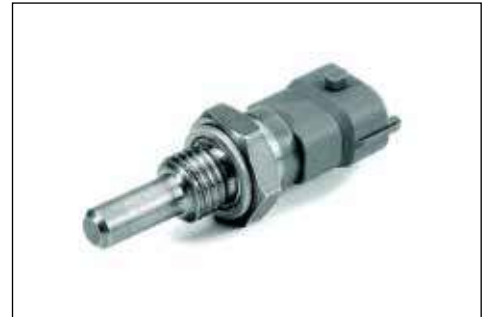
The sensor modifies a voltage signal from the electronic control unit (ECU).

The modified signal returns to the ECU as the engine coolant temperature input. The ECU checks CTS voltage and uses the information to help smoothen the engine operation.

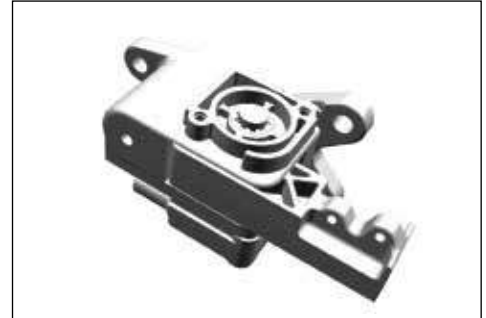
Accelerator pedal module (APM) consists of two sensors (Primary and Secondary) which act as a potentiometer and its output voltage changes according to the pedal position.

The ECU applies a reference voltage to the APM sensor and then measures the voltage that is present on the APM sensor signal circuit. The ECU uses the APM sensor signal for further calculation of fuelling and other engine operational parameters.

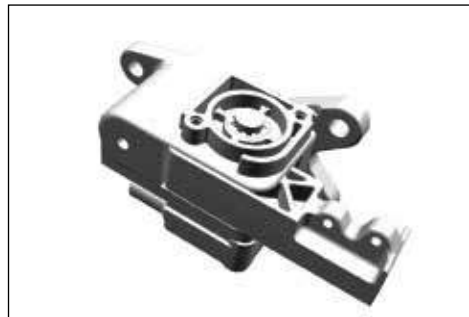
Accelerator pedal module (APM) consists of two sensors (Primary and Secondary) which act as a potentiometer and its output voltage changes according to the pedal position.

The ECU applies a reference voltage to the APM sensor and then measures the voltage that is present on the APM sensor signal circuit. The ECU uses the APM sensor signal for further calculation of fuelling and other engine operational parameters.

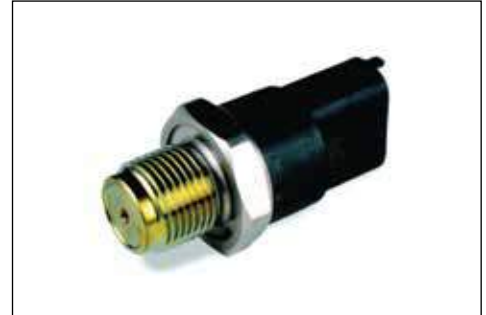
The rail pressure sensor (RPS) is a strain gauge device used to measure the pressure of the fuel near the fuel injectors. The electrical resistance of a strain gauge increases as pressure increases, and vice versa. The varying resistance affects the voltage drop across the sensor terminals and provides electrical signal corresponding to pressure to the electronic control unit (ECU).

The ECU compares the rail pressure monitored through the RPS against the expected pressure generated due to high pressure pump (HPP).

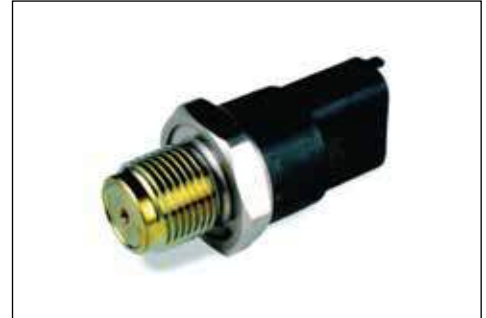
The rail pressure sensor (RPS) is a strain gauge device used to measure the pressure of the fuel near the fuel injectors. The electrical resistance of a strain gauge increases as pressure increases, and vice versa. The varying resistance affects the voltage drop across the sensor terminals and provides electrical signal corresponding to pressure to the electronic control unit (ECU).

The ECU compares the rail pressure monitored through the RPS against the expected pressure generated due to high pressure pump (HPP).

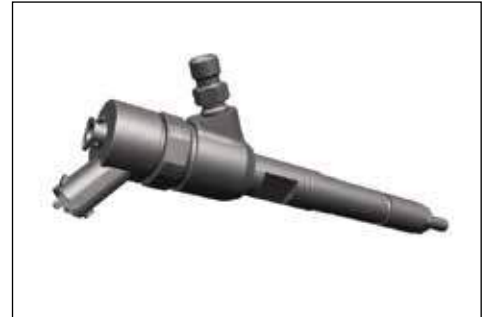
The injectors are solenoid actuated and controlled by ECU. The ECU measures the voltage drop through fixed resistors and controls it.

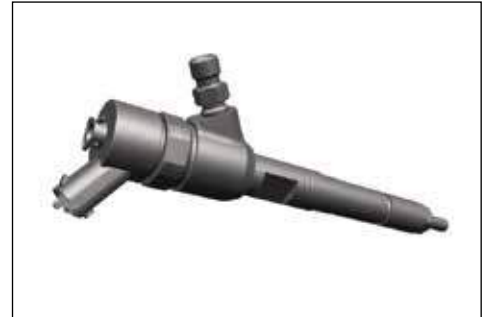
The injectors are solenoid actuated and controlled by ECU. The ECU measures the voltage drop through fixed resistors and controls it.

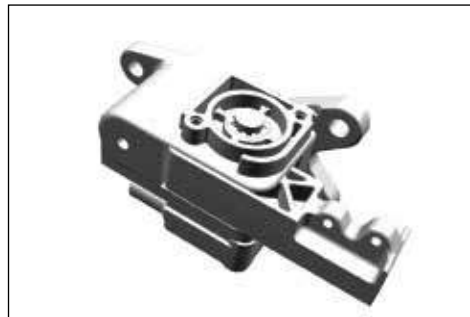
Accelerator pedal module (APM) consists of two sensors (Primary and Secondary) which act as a potentiometer and its output voltage changes according to the pedal position.

The ECU applies a reference voltage to the APM sensor and then measures the voltage that is present on the APM sensor signal circuit. The ECU uses the APM sensor signal for further calculation of fuelling and other engine operational parameters.

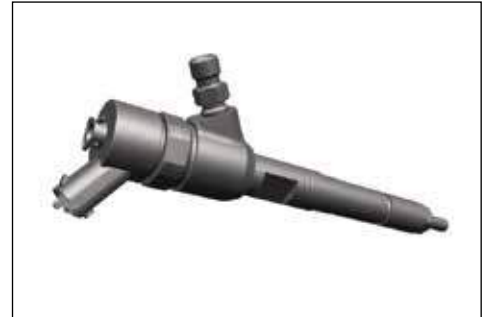
P0265 - GENERAL SHORT CIRCUIT - CYLINDER 2

The injectors are solenoid actuated and controlled by ECU. The ECU measures the voltage drop through fixed resistors and controls it.

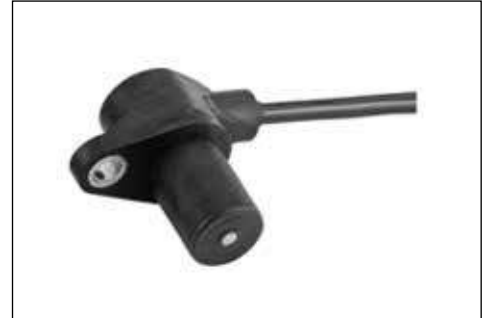
The crankshaft speed sensor (also known as the crank position sensor) is an electronic device used in an engine to record the rate at which the crankshaft is spinning. This information is used by the ECU to control fuel injection.

The sensor system consists of a rotating part, typically a disc, as well as a static part, the actual sensor. When the engine is running, the high and low parts of the teeth cause a change in gap with the sensor. The changing gap causes a change in the magnetic field near the sensor. The change in the magnetic field causes a change in the voltage from the sensor.

At normal vehicle condition, the ECU receives an output voltage signal (**0 to 140 V**) from the crankshaft speed sensor.

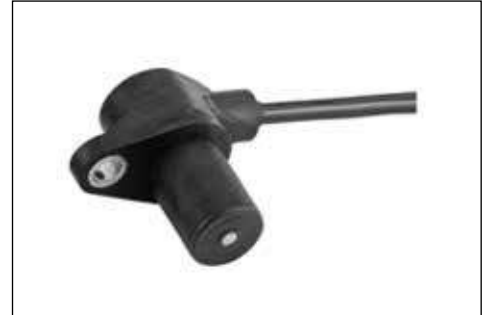
The crankshaft speed sensor (also known as the crank position sensor) is an electronic device used in an engine to record the rate at which the crankshaft is spinning. This information is used by the ECU to control fuel injection.

The sensor system consists of a rotating part, typically a disc, as well as a static part, the actual sensor. When the engine is running, the high and low parts of the teeth cause a change in gap with the sensor. The changing gap causes a change in the magnetic field near the sensor. The change in the magnetic field causes a change in the voltage from the sensor.

At normal vehicle condition, the ECU receives an output voltage signal (**0 to 140 V**) from the crankshaft speed sensor.

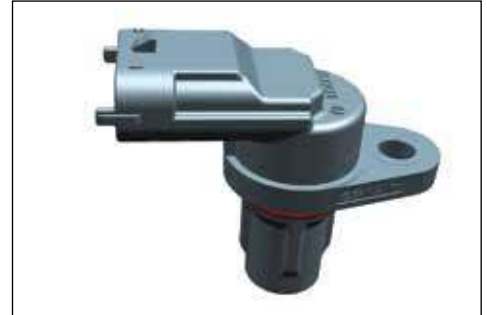
The Camshaft position sensor senses the Top dead center (TDC) point of the first cylinder in the compression stroke. This allows the ECU to determine when to start the injection.

Sensor records the rate at which the camshaft is spinning and this information is used by the ECU to control ignition and fuel injection.

At normal vehicle condition, the ECU receives an output voltage signal (**5Volts PWM Waveform**) from the camshaft position sensor.

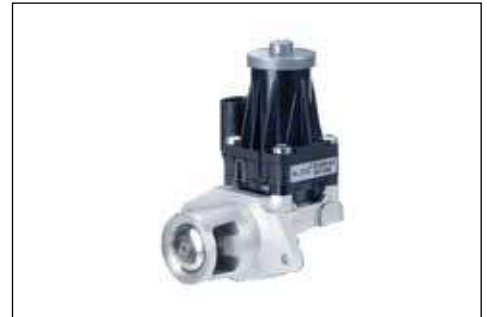
Electric Exhaust Gas Recirculation (EEGR) is a Nitrogen oxide (NO_x) emissions reduction technique used in engines. The EEGR Position sensor detects the movement and position of the EEGR valve pintle. The EEGR Pressure sensor detects exhaust gas flow through the EEGR passage.

EEGR valve position sensors are mounted on the top of the EEGR valve. EEGR pressure sensors will be located close to the EEGR valve as the exhaust gas hose must be connected to the sensor as well as the valve. The EEGR monitor is designed to detect insufficient or excessive EEGR flow and component performance. When the EEGR valve is open, the ECU confirms that exhaust gas is flowing. When the EEGR valve is shut off, the ECU confirms exhaust gas flow has stopped. The sensors are also monitored for open, shorts, and performance.

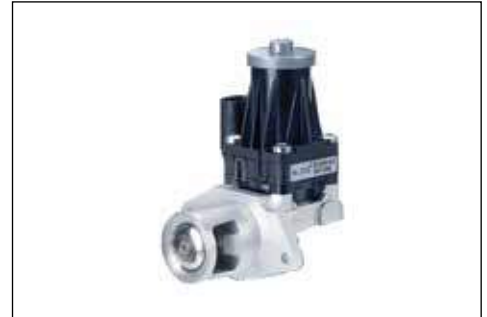
Electric Exhaust Gas Recirculation (EEGR) is a Nitrogen oxide (NOx) emissions reduction technique used in engines. The EEGR Position sensor detects the movement and position of the EEGR valve pintle. The EEGR Pressure sensor detects exhaust gas flow through the EEGR passage.

EEGR valve position sensors are mounted on the top of the EEGR valve. EEGR pressure sensors will be located close to the EEGR valve as the exhaust gas hose must be connected to the sensor as well as the valve. The EEGR monitor is designed to detect insufficient or excessive EEGR flow and component performance. When the EEGR valve is open, the ECU confirms that exhaust gas is flowing. When the EEGR valve is shut off, the ECU confirms exhaust gas flow has stopped. The sensors are also monitored for open, shorts, and performance.

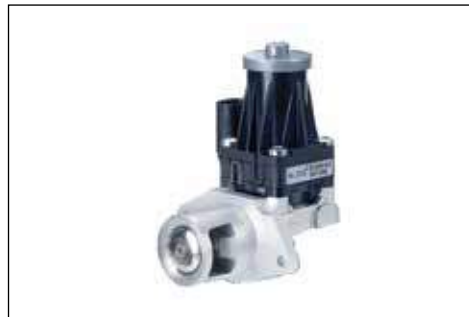
Electric Exhaust Gas Recirculation (EEGR) is a Nitrogen oxide (NOx) emissions reduction technique used in engines. The EEGR Position sensor detects the movement and position of the EEGR valve pintle. The EEGR Pressure sensor detects exhaust gas flow through the EEGR passage.

EEGR valve position sensors are mounted on the top of the EEGR valve. EEGR pressure sensors will be located close to the EEGR valve as the exhaust gas hose must be connected to the sensor as well as the valve. The EEGR monitor is designed to detect insufficient or excessive EEGR flow and component performance. When the EEGR valve is open, the ECU confirms that exhaust gas is flowing. When the EEGR valve is shut off, the ECU confirms exhaust gas flow has stopped. The sensors are also monitored for open, shorts, and performance.

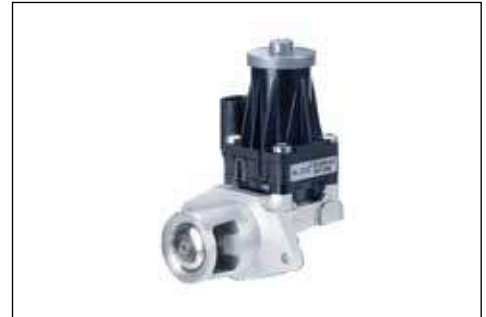
Electric Exhaust Gas Recirculation (EEGR) is a Nitrogen oxide (NOx) emissions reduction technique used in engines. The EEGR Position sensor detects the movement and position of the EEGR valve pintle. The EEGR Pressure sensor detects exhaust gas flow through the EEGR passage.

EEGR valve position sensors are mounted on the top of the EEGR valve. EEGR pressure sensors will be located close to the EEGR valve as the exhaust gas hose must be connected to the sensor as well as the valve. The EEGR monitor is designed to detect insufficient or excessive EEGR flow and component performance. When the EEGR valve is open, the ECU confirms that exhaust gas is flowing. When the EEGR valve is shut off, the ECU confirms exhaust gas flow has stopped. The sensors are also monitored for open, shorts, and performance.

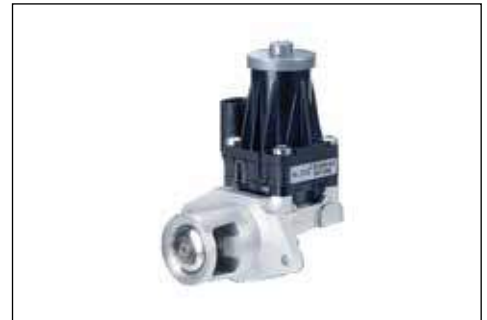
Electric Exhaust Gas Recirculation (EEGR) is a Nitrogen oxide (NOx) emissions reduction technique used in engines. The EEGR Position sensor detects the movement and position of the EEGR valve pintle. The EEGR Pressure sensor detects exhaust gas flow through the EEGR passage.

EEGR valve position sensors are mounted on the top of the EEGR valve. EEGR pressure sensors will be located close to the EEGR valve as the exhaust gas hose must be connected to the sensor as well as the valve. The EEGR monitor is designed to detect insufficient or excessive EEGR flow and component performance. When the EEGR valve is open, the ECU confirms that exhaust gas is flowing. When the EEGR valve is shut off, the ECU confirms exhaust gas flow has stopped. The sensors are also monitored for open, shorts, and performance.

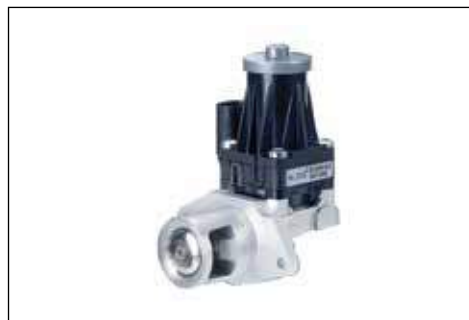
Electric Exhaust Gas Recirculation (EEGR) is a Nitrogen oxide (NOx) emissions reduction technique used in engines. The EEGR Position sensor detects the movement and position of the EEGR valve pintle. The EEGR Pressure sensor detects exhaust gas flow through the EEGR passage.

EEGR valve position sensors are mounted on the top of the EEGR valve. EEGR pressure sensors will be located close to the EEGR valve as the exhaust gas hose must be connected to the sensor as well as the valve. The EEGR monitor is designed to detect insufficient or excessive EEGR flow and component performance. When the EEGR valve is open, the ECU confirms that exhaust gas is flowing. When the EEGR valve is shut off, the ECU confirms exhaust gas flow has stopped. The sensors are also monitored for open, shorts, and performance.

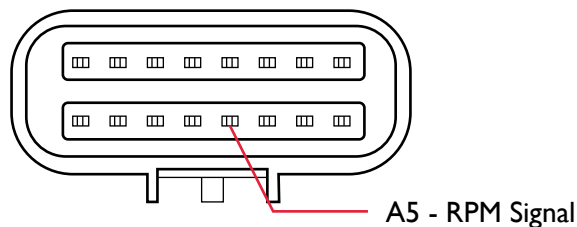
Instrument Cluster Connector Pin Details

Image shown is applicable for 6000 series model and the connector pin details may vary for other models.

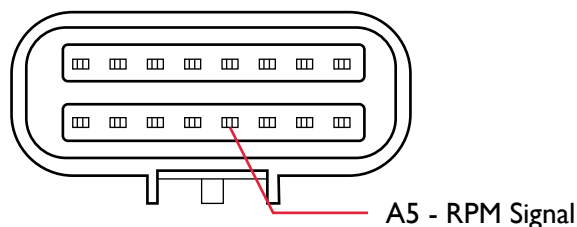
Instrument Cluster Connector Pin Details

Image shown is applicable for 6000 series model and the connector pin details may vary for other models.

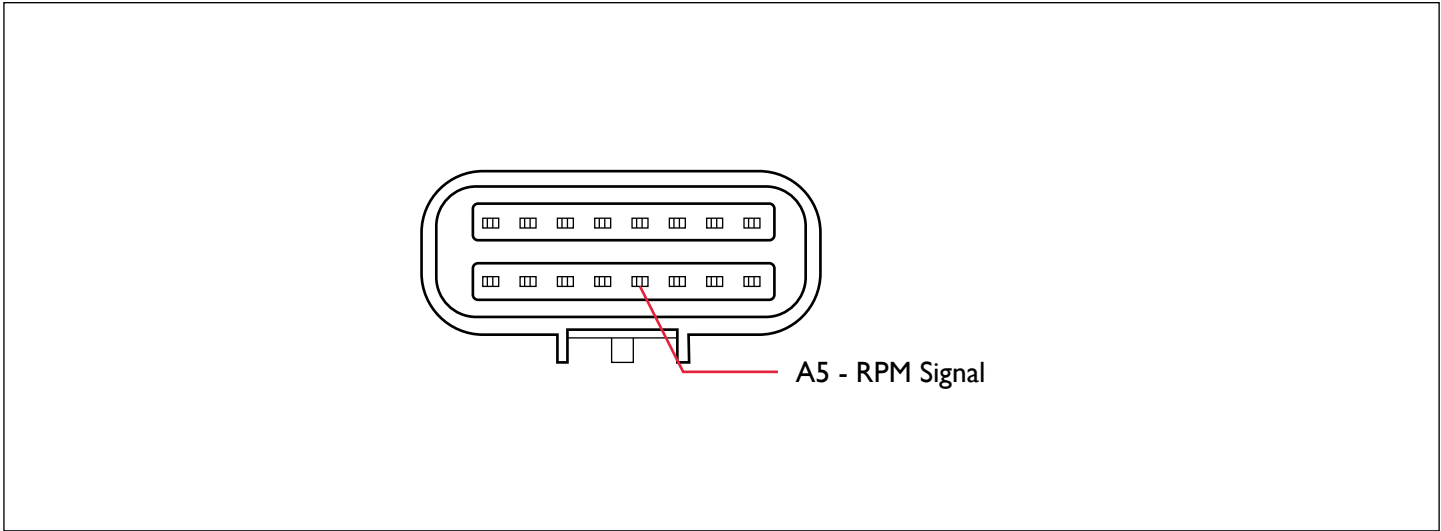
Instrument Cluster Connector Pin Details

Image shown is applicable for 6000 series model and the connector pin details may vary for other models.

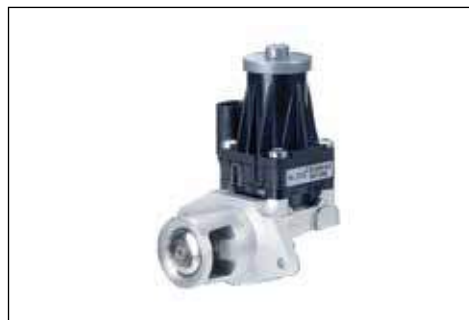
Electric Exhaust Gas Recirculation (EEGR) is a Nitrogen oxide (NOx) emissions reduction technique used in engines. The EEGR Position sensor detects the movement and position of the EEGR valve pintle. The EEGR Pressure sensor detects exhaust gas flow through the EEGR passage.

EEGR valve position sensors are mounted on the top of the EEGR valve. EEGR pressure sensors will be located close to the EEGR valve as the exhaust gas hose must be connected to the sensor as well as the valve. The EEGR monitor is designed to detect insufficient or excessive EEGR flow and component performance. When the EEGR valve is open, the ECU confirms that exhaust gas is flowing. When the EEGR valve is shut off, the ECU confirms exhaust gas flow has stopped. The sensors are also monitored for open, shorts, and performance.

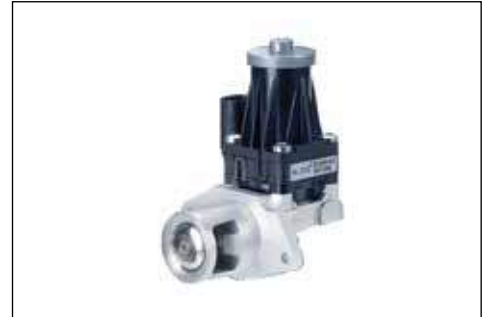
Electric Exhaust Gas Recirculation (EEGR) is a Nitrogen oxide (NOx) emissions reduction technique used in engines. The EEGR Position sensor detects the movement and position of the EEGR valve pintle. The EEGR Pressure sensor detects exhaust gas flow through the EEGR passage.

EEGR valve position sensors are mounted on the top of the EEGR valve. EEGR pressure sensors will be located close to the EEGR valve as the exhaust gas hose must be connected to the sensor as well as the valve. The EEGR monitor is designed to detect insufficient or excessive EEGR flow and component performance. When the EEGR valve is open, the ECU confirms that exhaust gas is flowing. When the EEGR valve is shut off, the ECU confirms exhaust gas flow has stopped. The sensors are also monitored for open, shorts, and performance.

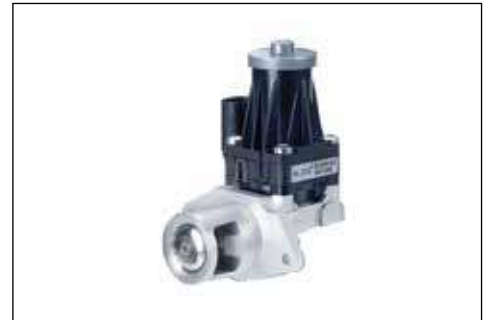
Electric Exhaust Gas Recirculation (EEGR) is a Nitrogen oxide (NOx) emissions reduction technique used in engines. The EEGR Position sensor detects the movement and position of the EEGR valve pintle. The EEGR Pressure sensor detects exhaust gas flow through the EEGR passage.

EEGR valve position sensors are mounted on the top of the EEGR valve. EEGR pressure sensors will be located close to the EEGR valve as the exhaust gas hose must be connected to the sensor as well as the valve. The EEGR monitor is designed to detect insufficient or excessive EEGR flow and component performance. When the EEGR valve is open, the ECU confirms that exhaust gas is flowing. When the EEGR valve is shut off, the ECU confirms exhaust gas flow has stopped. The sensors are also monitored for open, shorts, and performance.

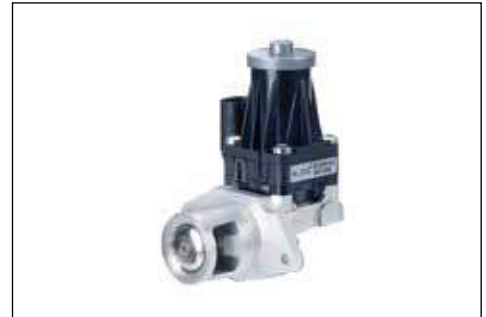
Electric Exhaust Gas Recirculation (EEGR) is a Nitrogen oxide (NOx) emissions reduction technique used in engines. The EEGR Position sensor detects the movement and position of the EEGR valve pintle. The EEGR Pressure sensor detects exhaust gas flow through the EEGR passage.

EEGR valve position sensors are mounted on the top of the EEGR valve. EEGR pressure sensors will be located close to the EEGR valve as the exhaust gas hose must be connected to the sensor as well as the valve. The EEGR monitor is designed to detect insufficient or excessive EEGR flow and component performance. When the EEGR valve is open, the ECU confirms that exhaust gas is flowing. When the EEGR valve is shut off, the ECU confirms exhaust gas flow has stopped. The sensors are also monitored for open, shorts, and performance.

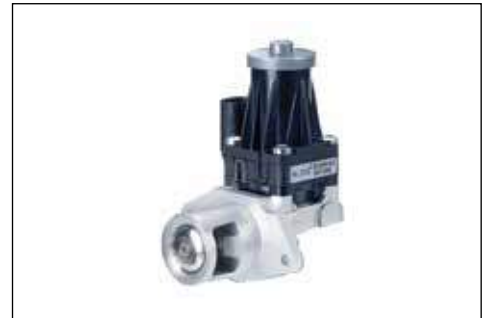
Electric Exhaust Gas Recirculation (EEGR) is a Nitrogen oxide (NOx) emissions reduction technique used in engines. The EEGR Position sensor detects the movement and position of the EEGR valve pintle. The EEGR Pressure sensor detects exhaust gas flow through the EEGR passage.

EEGR valve position sensors are mounted on the top of the EEGR valve. EEGR pressure sensors will be located close to the EEGR valve as the exhaust gas hose must be connected to the sensor as well as the valve. The EEGR monitor is designed to detect insufficient or excessive EEGR flow and component performance. When the EEGR valve is open, the ECU confirms that exhaust gas is flowing. When the EEGR valve is shut off, the ECU confirms exhaust gas flow has stopped. The sensors are also monitored for open, shorts, and performance.

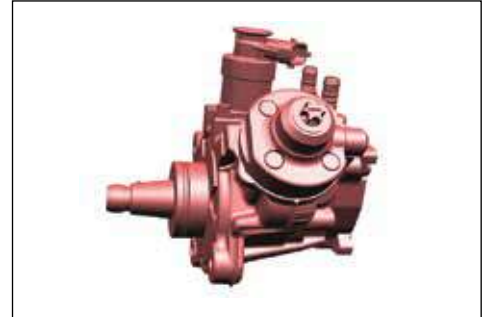
PI203 - MINIMUM RAIL PRESSURE CHECK FAILED DUE TO LESS RAIL PRESSURE

The metering unit is used for compressing the fuel at high pressure and sending it at pressurized stage towards the rail, which is controlled by ECU.

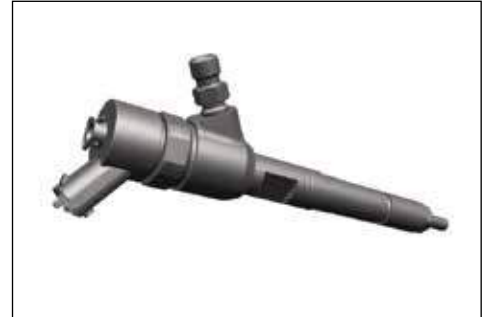
PI204 - INJECTOR BANK - SHORT CIRCUIT

The injectors are solenoid actuated and controlled by ECU. The ECU measures the voltage drop through fixed resistors and controls it.

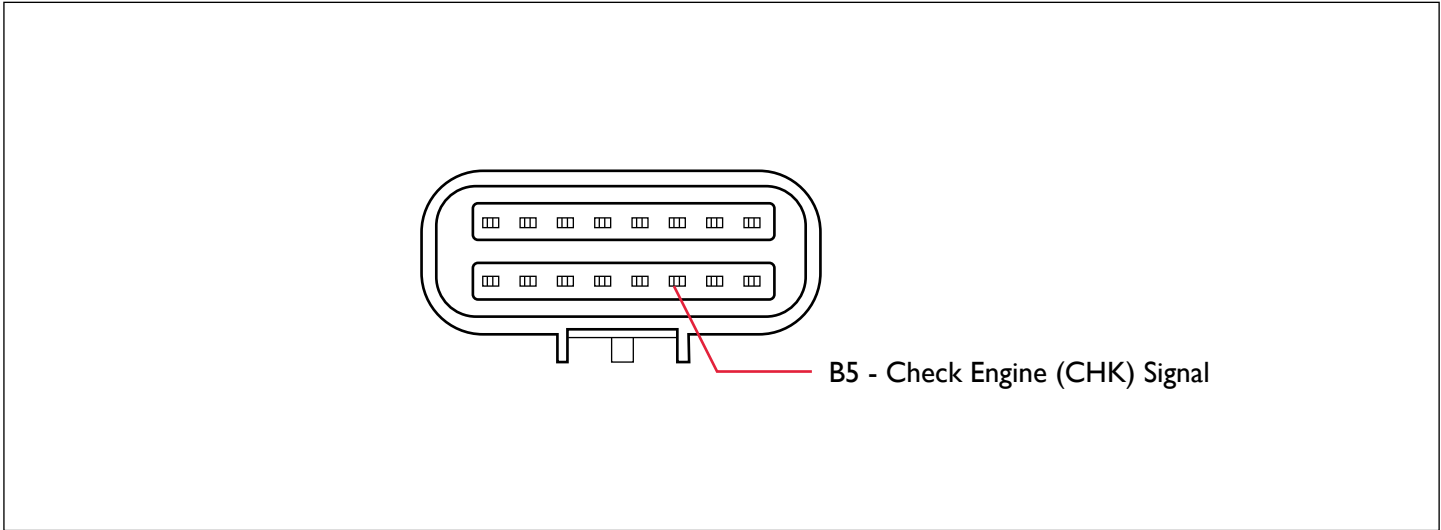
Instrument Cluster Connector Pin Details

Image shown is applicable for 6000 series model and the connector pin details may vary for other models.

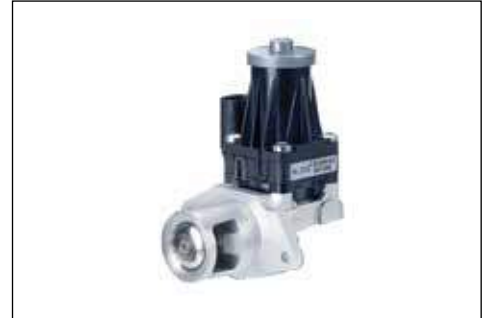
Electric Exhaust Gas Recirculation (EEGR) is a Nitrogen oxide (NOx) emissions reduction technique used in engines. The EEGR Position sensor detects the movement and position of the EEGR valve pintle. The EEGR Pressure sensor detects exhaust gas flow through the EEGR passage.

EEGR valve position sensors are mounted on the top of the EEGR valve. EEGR pressure sensors will be located close to the EEGR valve as the exhaust gas hose must be connected to the sensor as well as the valve. The EEGR monitor is designed to detect insufficient or excessive EEGR flow and component performance. When the EEGR valve is open, the ECU confirms that exhaust gas is flowing. When the EEGR valve is shut off, the ECU confirms exhaust gas flow has stopped. The sensors are also monitored for open, shorts, and performance.

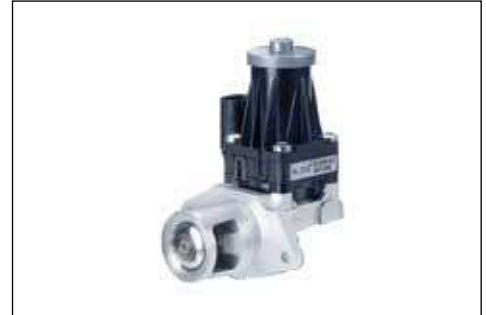
Electric Exhaust Gas Recirculation (EEGR) is a Nitrogen oxide (NOx) emissions reduction technique used in engines. The EEGR Position sensor detects the movement and position of the EEGR valve pintle. The EEGR Pressure sensor detects exhaust gas flow through the EEGR passage.

EEGR valve position sensors are mounted on the top of the EEGR valve. EEGR pressure sensors will be located close to the EEGR valve as the exhaust gas hose must be connected to the sensor as well as the valve. The EEGR monitor is designed to detect insufficient or excessive EEGR flow and component performance. When the EEGR valve is open, the ECU confirms that exhaust gas is flowing. When the EEGR valve is shut off, the ECU confirms exhaust gas flow has stopped. The sensors are also monitored for open, shorts, and performance.

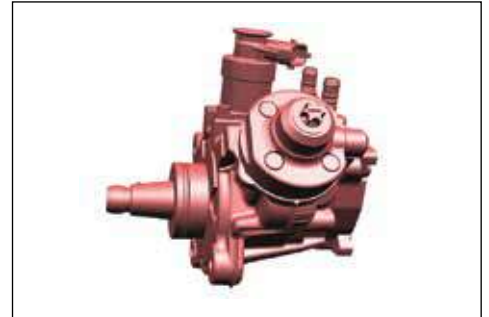
PI416 - LOOSE CONTACT BETWEEN METERING UNIT AND ECU

The metering unit is used for compressing the fuel at high pressure and sending it at pressurized stage towards the rail, which is controlled by ECU.

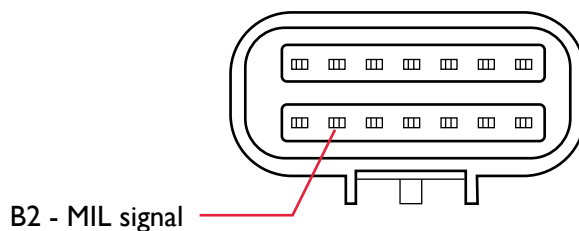
Instrument Cluster Connector Pin Details

Image shown is applicable for 6000 series model and the connector pin details may vary for other models.

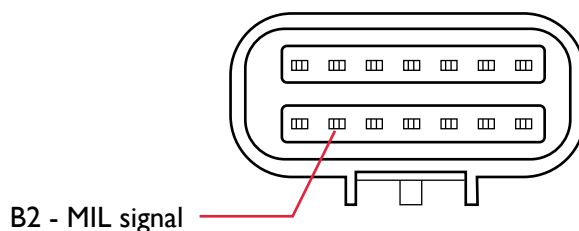
Instrument Cluster Connector Pin Details

Image shown is applicable for 6000 series model and the connector pin details may vary for other models.

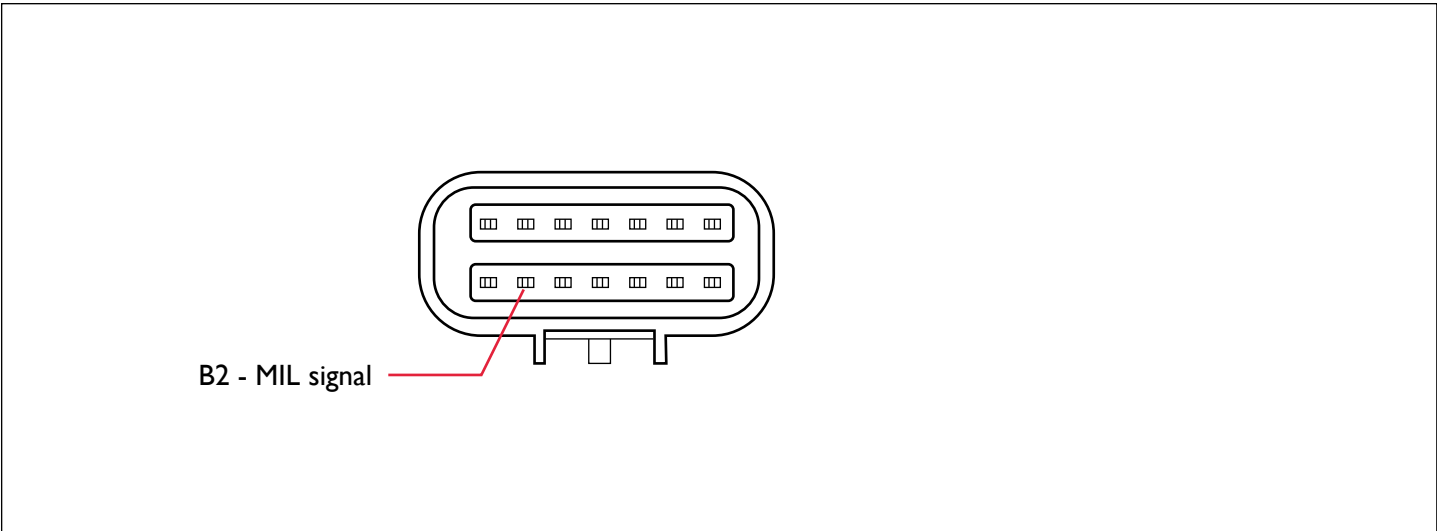
Instrument Cluster Connector Pin Details

Image shown is applicable for 6000 series model and the connector pin details may vary for other models.

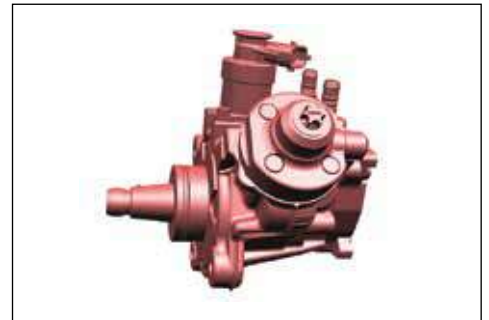
PI 423 - MAXIMUM RAIL PRESSURE LIMIT EXCEEDED

The metering unit is used for compressing the fuel at high pressure and sending it at pressurized stage towards the rail, which is controlled by ECU.

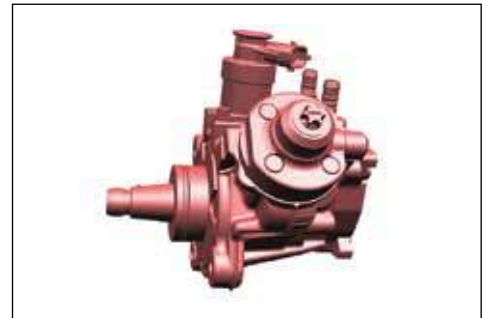
PI 424 - MAXIMUM RAIL PRESSURE LIMIT EXCEEDED (2ND STAGE)

The metering unit is used for compressing the fuel at high pressure and sending it at pressurized stage towards the rail, which is controlled by ECU.

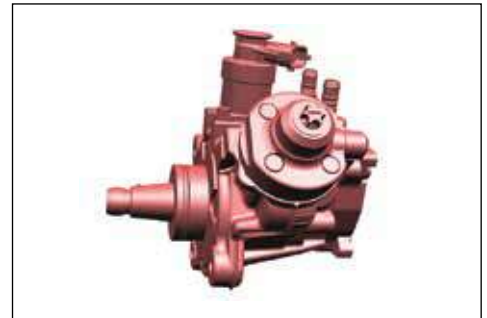
PI 602 - RAIL PRESSURE NEGATIVE GOVERNOR DEVIATION - ACTUAL RAIL PRESSURE IS MORE THAN THE DESIRED VALUE

The metering unit is used for compressing the fuel at high pressure and sending it at pressurized stage towards the rail, which is controlled by ECU.

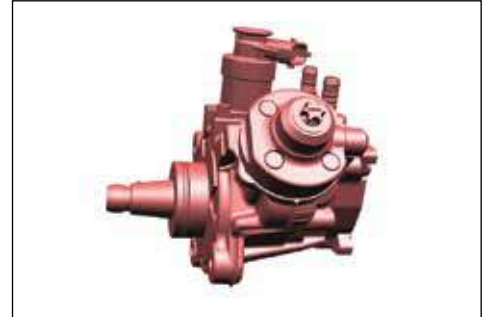
PI 606 - PUMP METERING UNIT PLAUSIBILITY ERROR AT IDLING

The metering unit is used for compressing the fuel at high pressure and sending it at pressurized stage towards the rail, which is controlled by ECU.

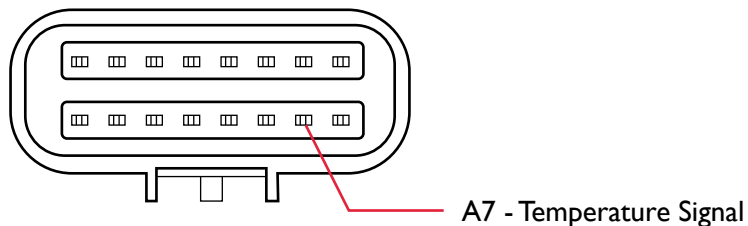
Instrument Cluster Connector Pin Details

Image shown is applicable for 6000 series model and the connector pin details may vary for other models.

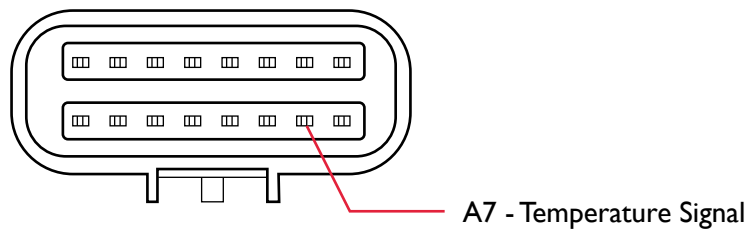
Instrument Cluster Connector Pin Details

Image shown is applicable for 6000 series model and the connector pin details may vary for other models.

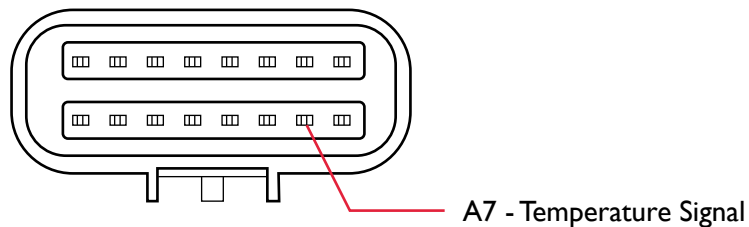
Instrument Cluster Connector Pin Details

Image shown is applicable for 6000 series model and the connector pin details may vary for other models.

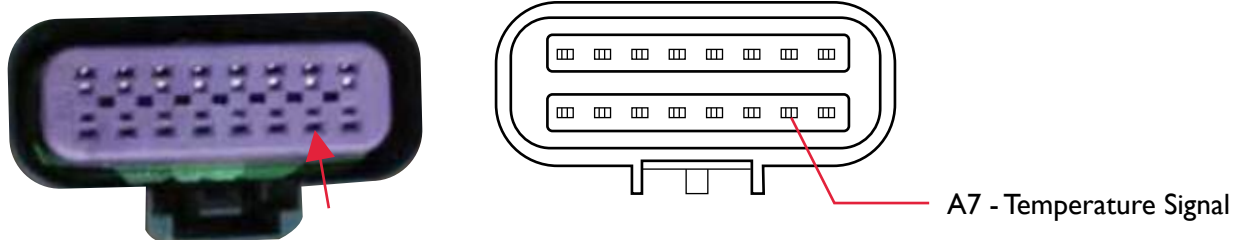
Instrument Cluster Connector Pin Details

Image shown is applicable for 6000 series model and the connector pin details may vary for other models.

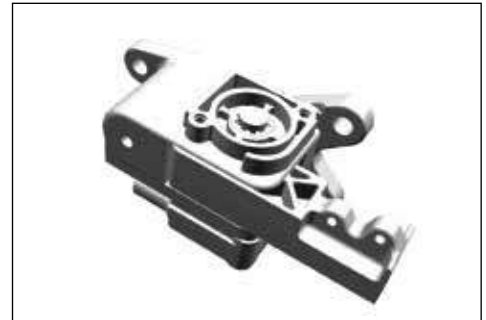
Accelerator pedal module (APM) consists of two sensors (Primary and Secondary) which act as a potentiometer and its output voltage changes according to the pedal position.

The ECU applies a reference voltage to the APM sensor and then measures the voltage that is present on the APM sensor signal circuit. The ECU uses the APM sensor signal for further calculation of fuelling and other engine operational parameters.
